The Chapel of Saint Frodulphe, Barjon, France

Title of Module: AR7524 The Archaeology of Standing Buildings

The Chapel of St. Frodulphe

Barjon, France

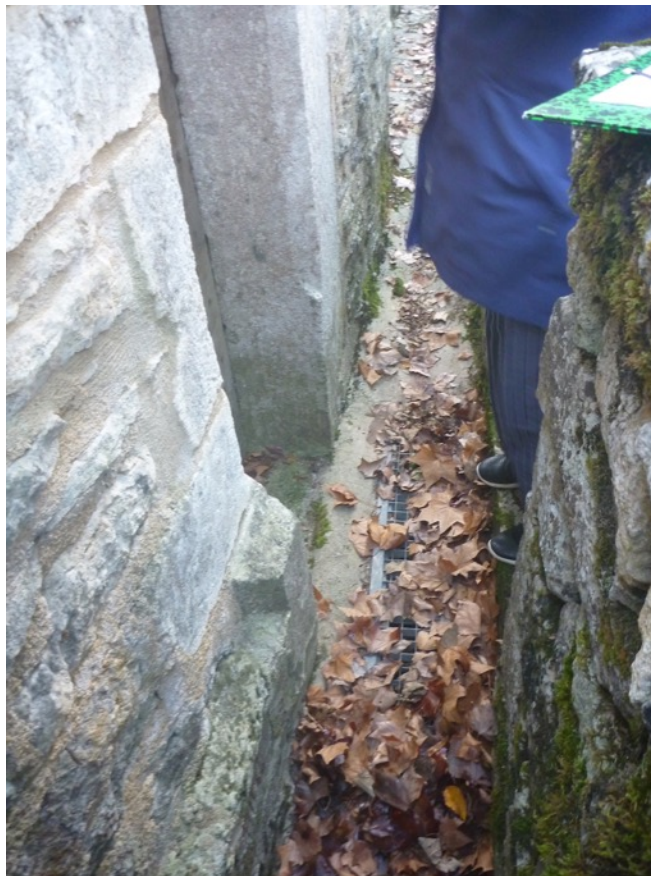
Figure 4: View towards the west of the ground around the north door with the narrow gap between the wall of the chapel (left) and the retaining wall (right). Note the plinth courses on the east side of the door and the absence of plinth courses on the west side.

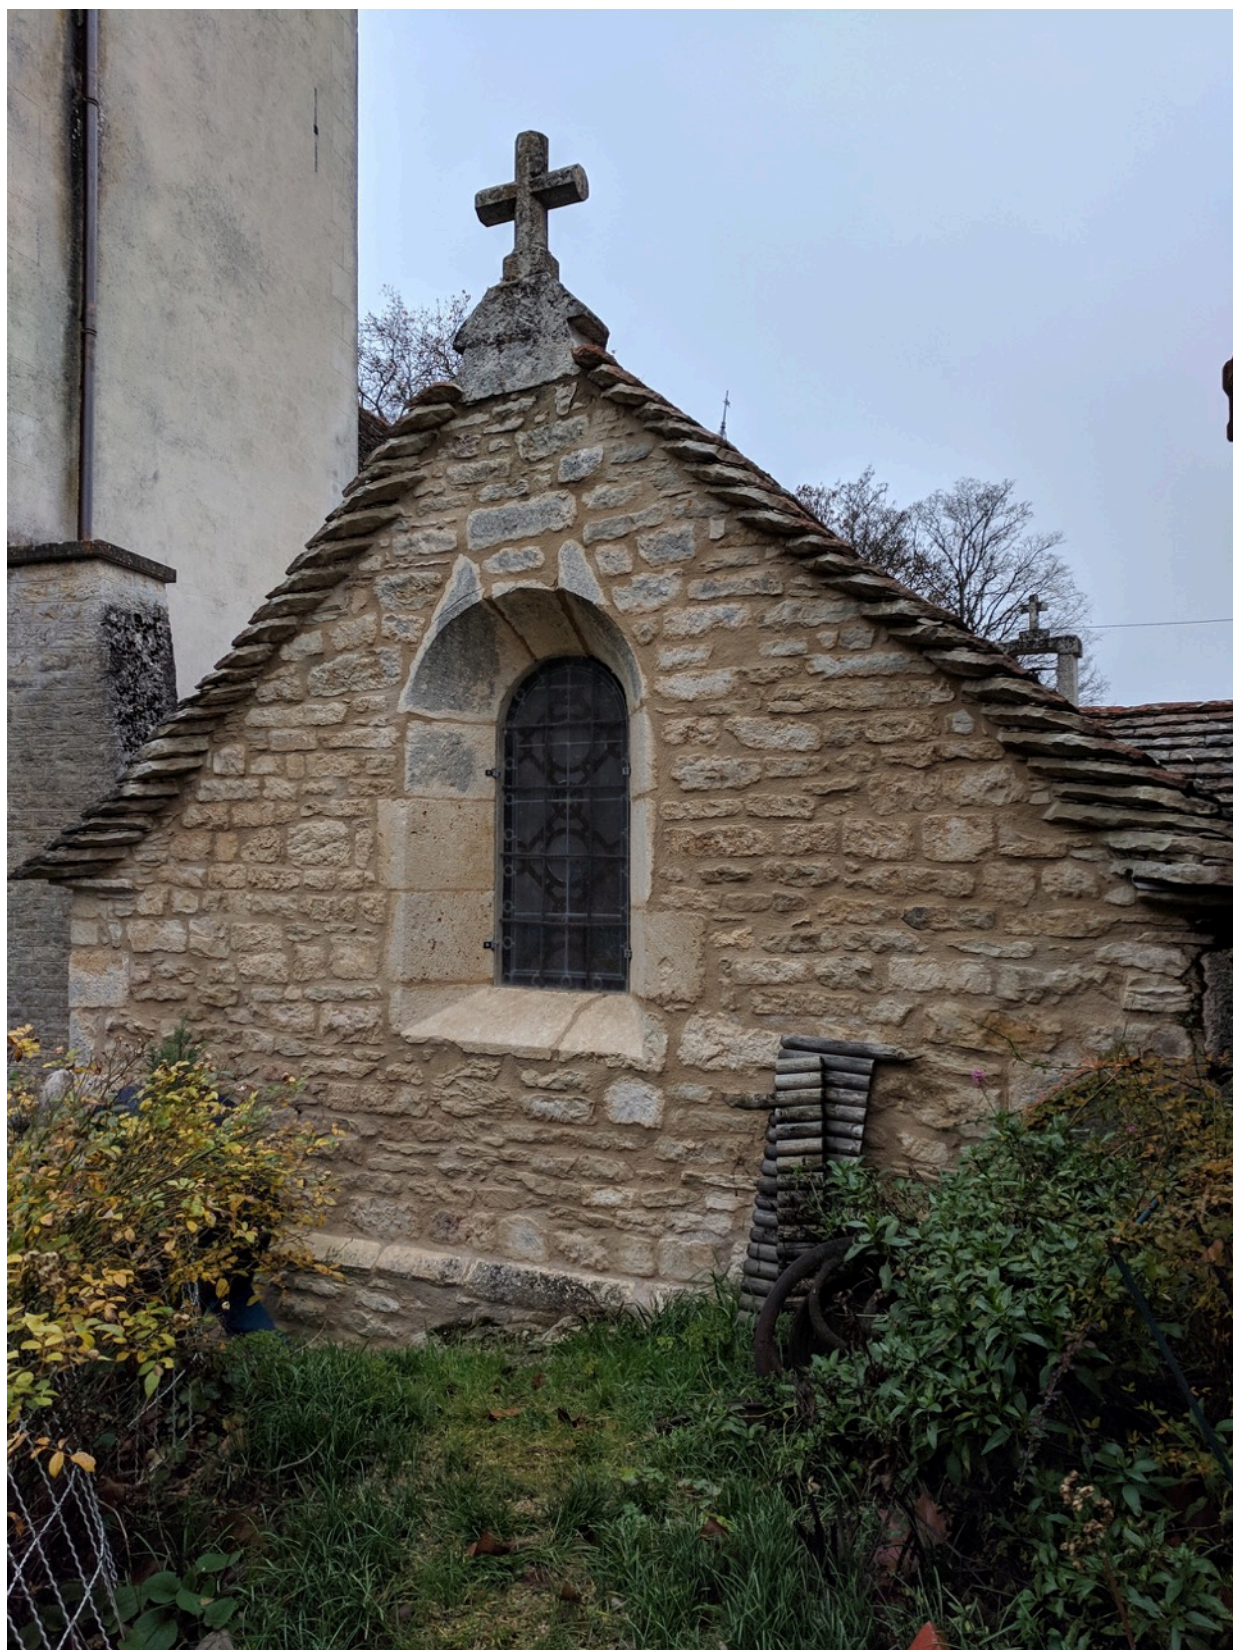
Figure 6: East end of chapel.

The east side of the building (Figure 6) is pierced by a protected, stain glass window 0.62 metres wide and 1.48 metres tall in a recess composed of well dressed stone. A moulded plinth supports the base of the wall, but the plinth wall is 0.90 metres high at the exposed southeast end. The interior floor of the chancel is calculated to be 0.22 metres above this visible edge; the floor

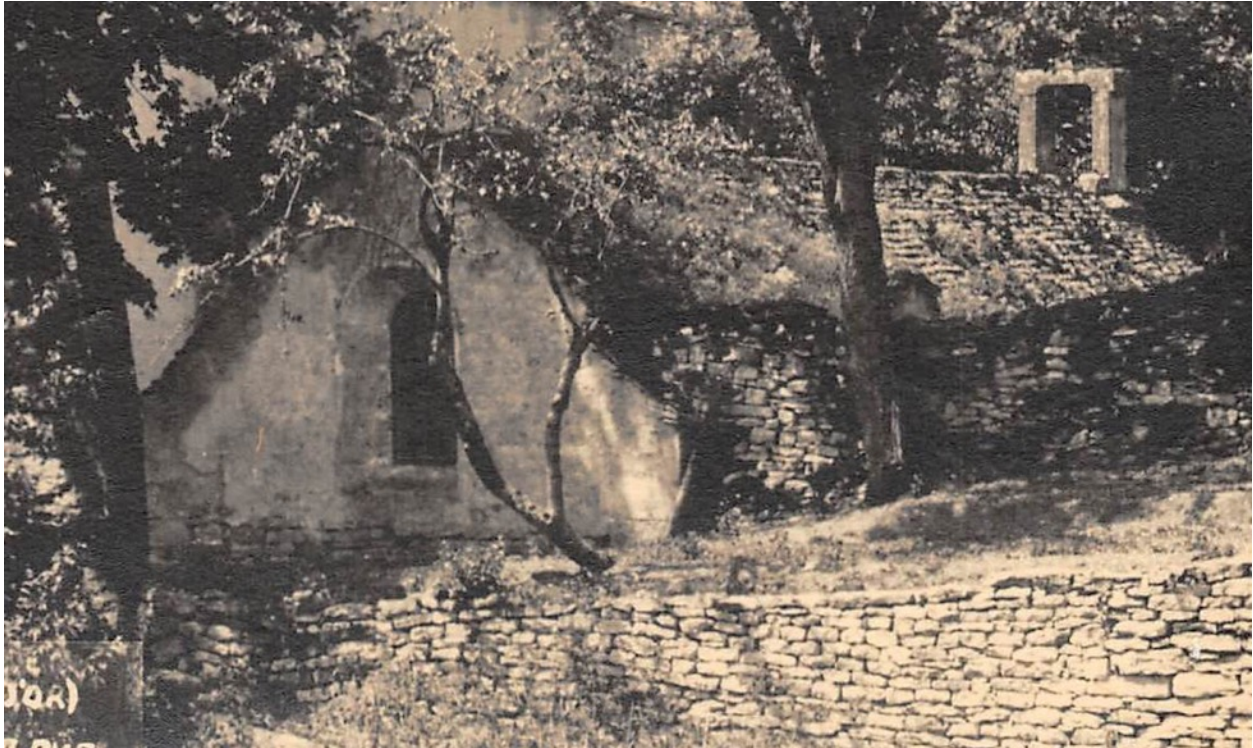
Figure 7: Early view of east end of chapel (undated postcard with unknown provenance).

of the nave is only 0.08 metres above it. A stone cross with attached base sits atop the eastern wall of the chapel. The base sits 3.26 metres above the top of the plinth. Thus the total elevation from the ground at the southeast corner is 4.16 metres. Generally the stone of the east end of the building appears relatively consistent in colour. It is the only side of the building that can be compared to early photographs as found on an undated, purchased postcard (Figure 7, BERGER 2018). The use of such an unprovenanced source is questionable, but as the only available early photograph it seemed too important to neglect. Various walls and vegetation obscure the chapel in the postcard, but the presence of some sort of degenerating plaster covering is obvious. A stone wall appears to abut the chapel at the northeast corner and stretches off to the north. The standing chapel abuts a modern garage built next to a stone wall isolating the cemetery; this wall appears to follow the same line as the wall in the postcard. The adjoining property at the

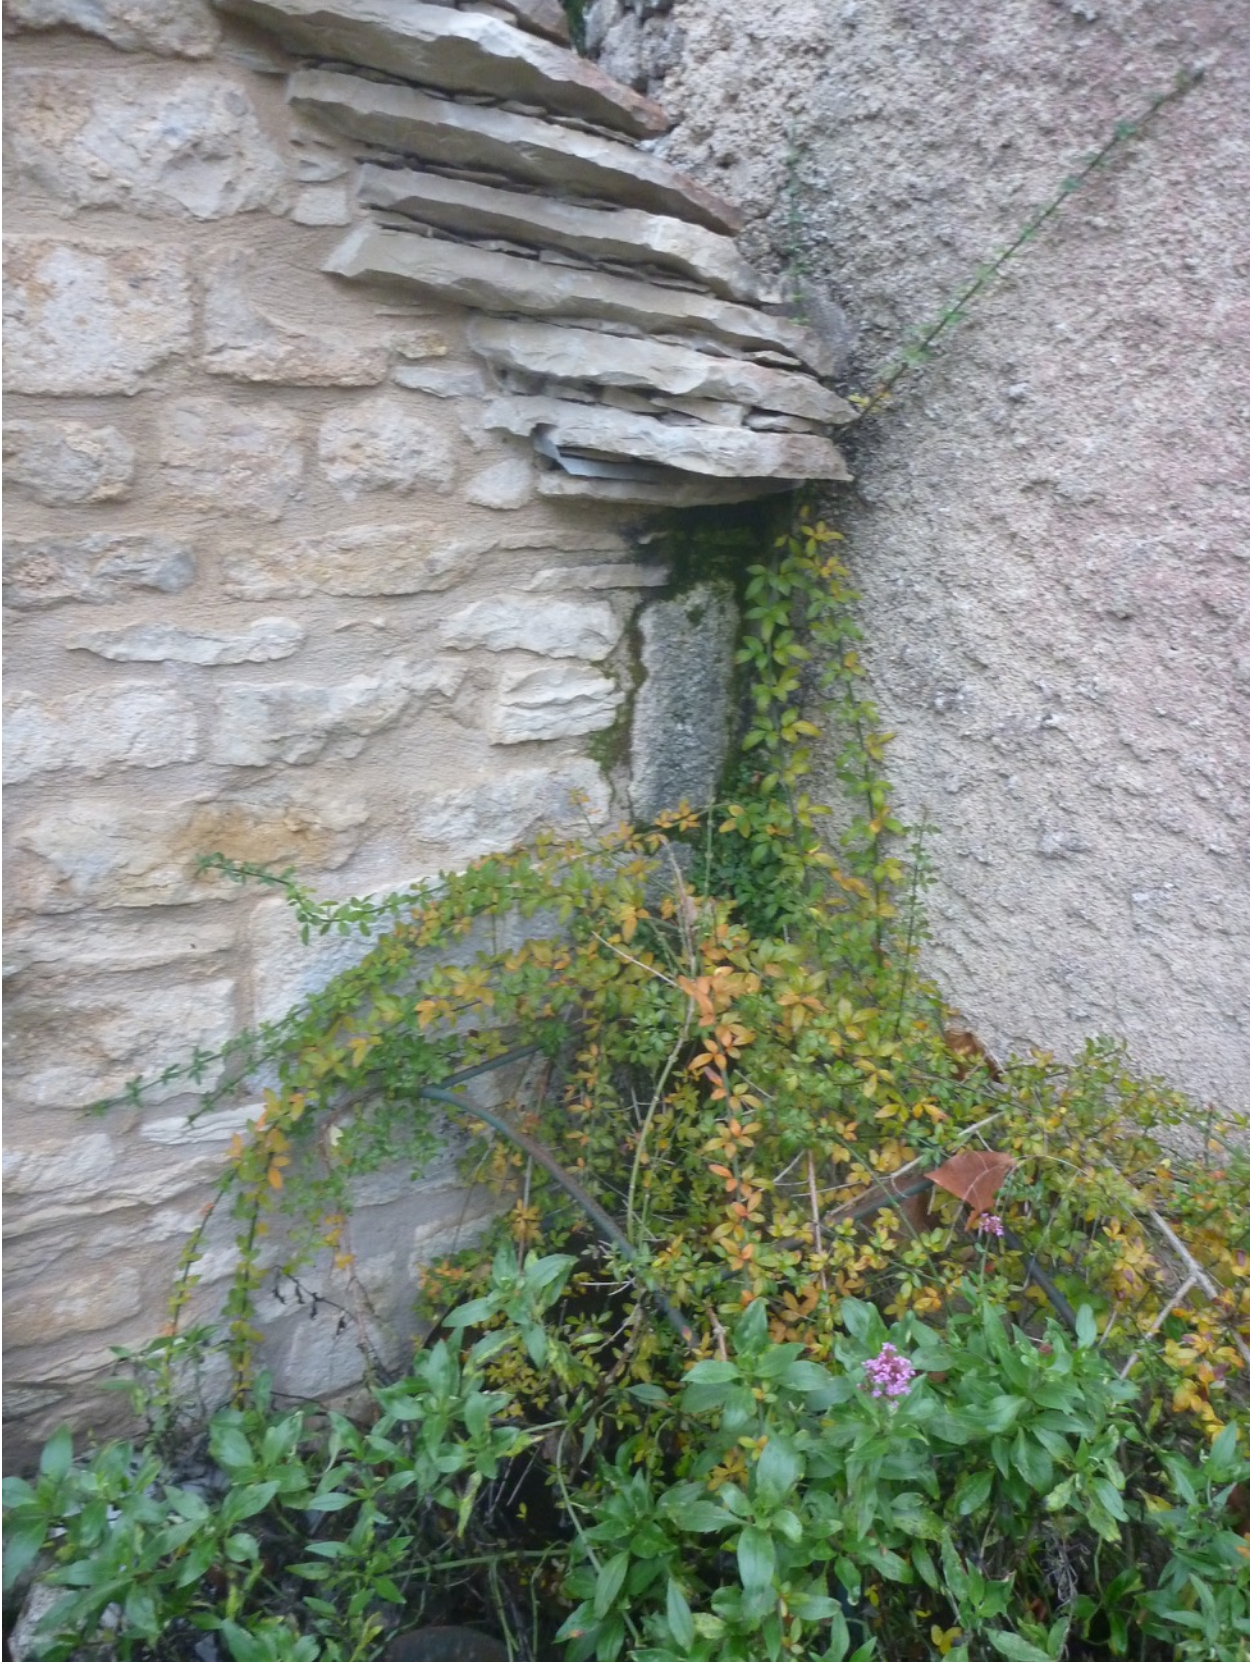
Figure 8: Detail of east end at northeast corner.

northeast corner is currently privately owned, and private possessions and plants obscured the intersection with the modern garage (Figure 8). Nonetheless, some of the quoining can be identified as long-and-short work; these quoins touch the wall of the garage. On the same private property, exterior steps leading to a terraced piece of land obscure most of the lower courses of the plinth wall (Figure 9). The measured width to the edge of the quoins is 4.80 metres. This represents the edge of the chapel, and the measured lengths of the various sides of the building cannot be reconciled without using that length.

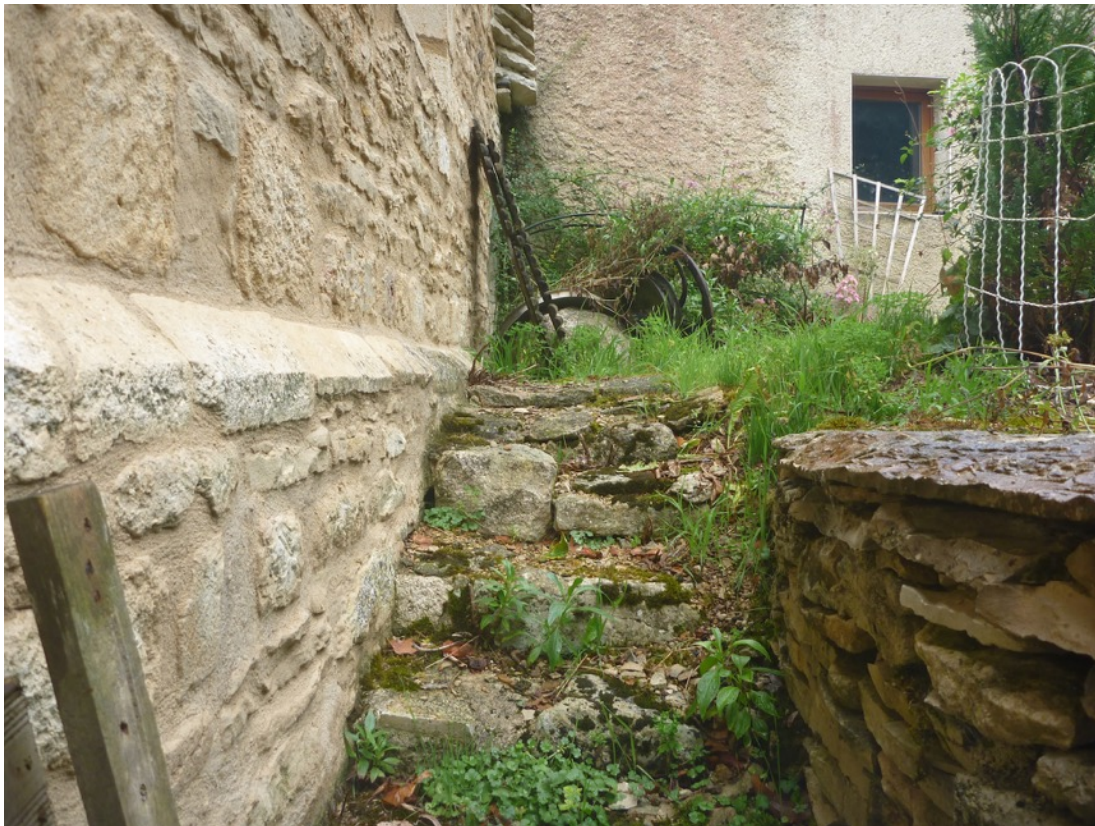
Figure 9: View towards north of east end along the plinth course.

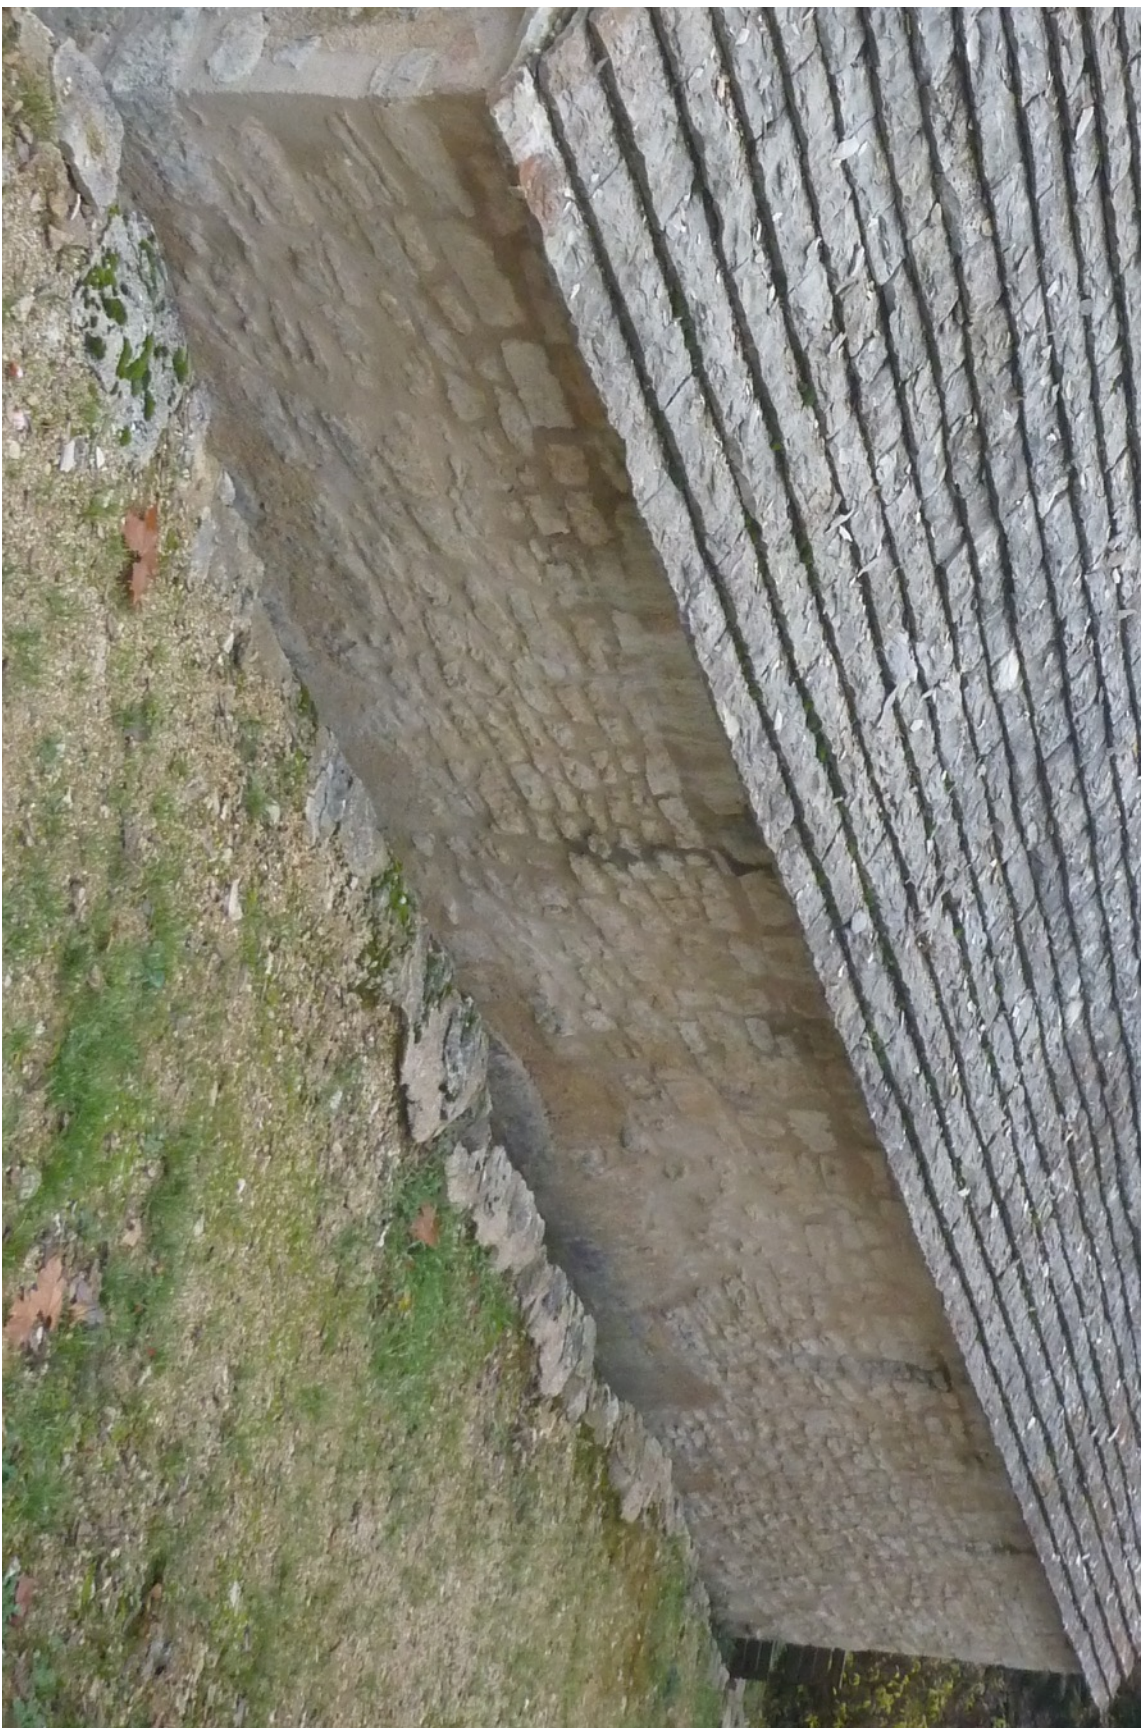
Figure 10: The south wall from the southwest.

The south wall of the building (Figure 10) has wide variations in shapes of the stones, and different types of mortar, and perhaps even remnants of the plaster shown in the antique postcard. The surface is reasonably clean despite some stains caused by moisture absorbed into

the mortar. The close proximity of the chateau prevents taking a single photograph directly from the front. The south wall is 12.73 metres long. At the west end, the wall rises 1.51 metres from the ground to the eaves, but at the east end, it rises 2.27 metres from the ground. This wall is easily seen to have three broad phases: a well ordered eastern end, a less well ordered western end, and a rather disordered central section. A noticeable bulge occurs in the wall toward the

The southern wall, however, tells a different story (Figure 10). Three gross phases are seen in the exterior of the southern wall, each of approximately equal length. The stonework of the central section of the wall is comparatively disordered compared to either end. The workmanship and even some of the stones themselves are unlike any other part of the exterior wall (Figure 13). This odd stonework might have been associated with a low-lying entrance into the chapel, perhaps from the chateau which is less than five metres to the south and originally on a downward slope. The different phases of the southern wall combined with the consistent

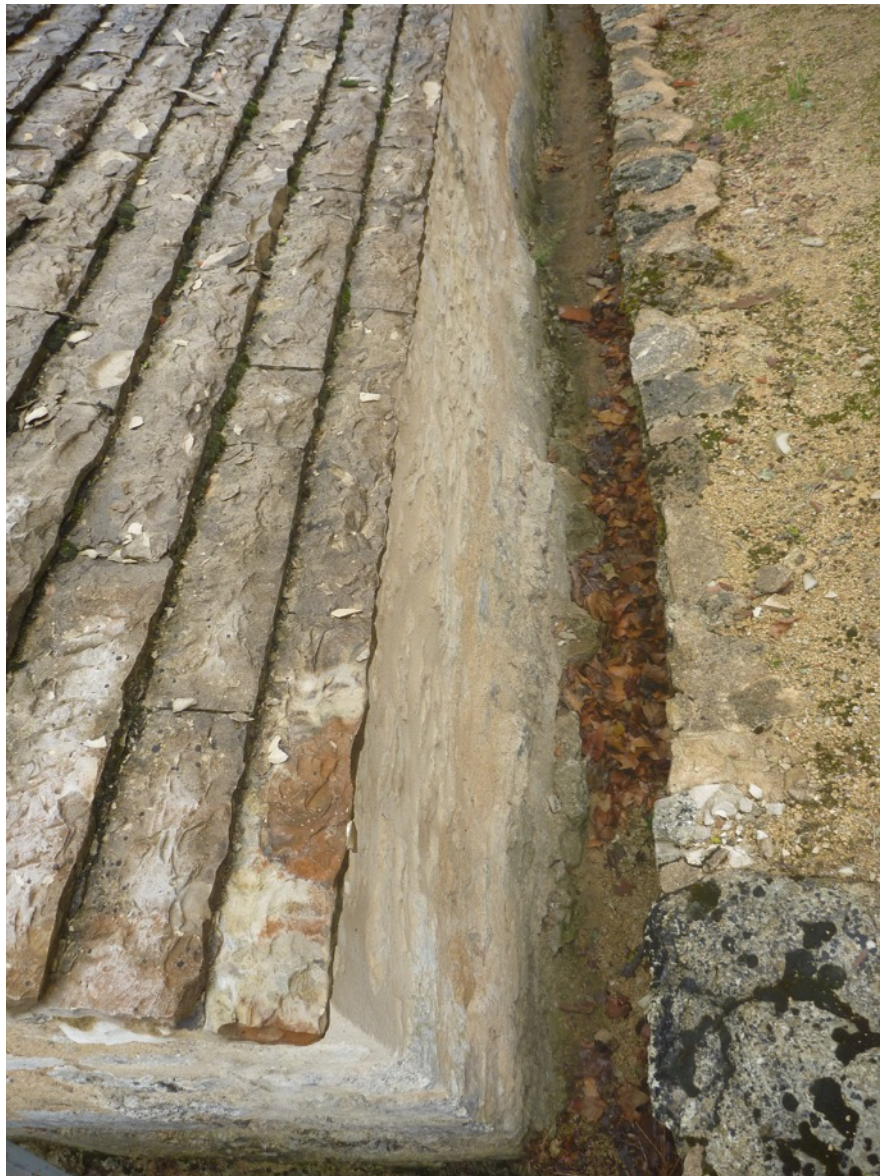
Figure 11: Southwest corner from above retaining wall.

west end and is easily detected when looking along the wall towards the east (Figures 11 and 12). As the modern concrete and weak quoining in the southeast corner suggests, this section of wall seems to have been modified repeatedly over the years. This section ends approximately at the westernmost, large visible moisture stain shown in Figure 10; thus, it stretches from the western end to approximately the first 3.5 to 4.0 metres east along the wall. The central section of the

The western end of the chapel appears to be a later addition. On the southern wall towards the western end a noticeable bulge in the stonework occurs at the base of the exterior wall (Figures 11 and 12). The western face of the chapel is a rather odd mixture of stone and styles (Figure 14). The windows are at different heights and are reinforced with iron bars. Perhaps these were added to help with the moisture levels inside the chapel. What appears to be modern concrete is used in the southwest corner of the building as opposed to quoins. The western door does not align with the threshold stone nor with the peak in the ceiling (Figure 19). All of these observations align with the idea of numerous modifications, some apparently within the last century.

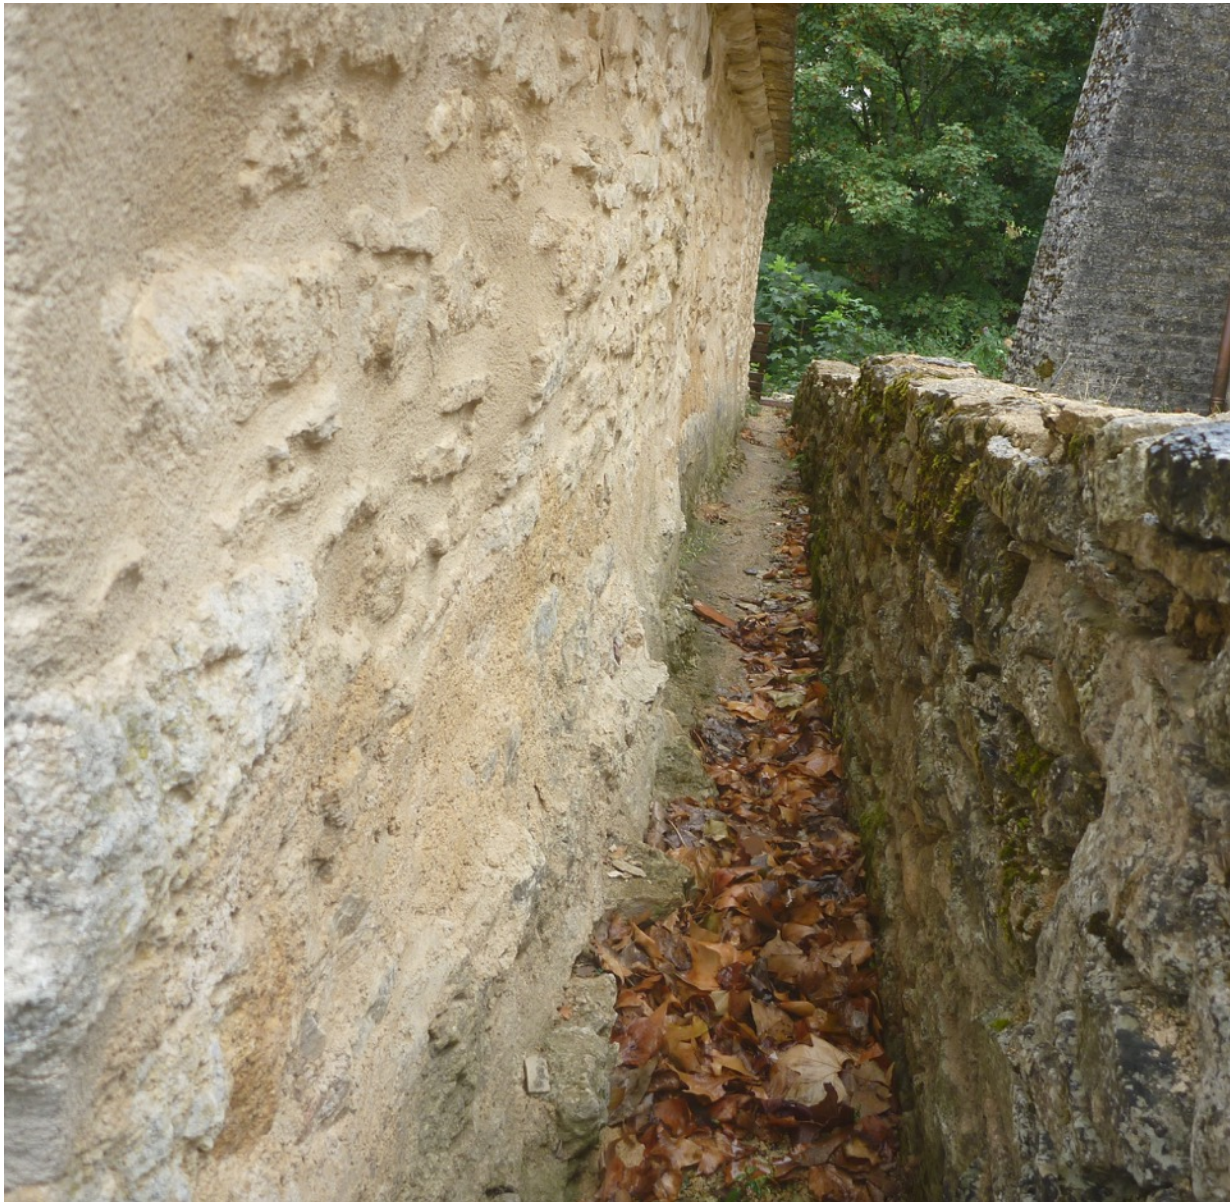
Figure 12: View along the south wall towards the east. Note the bulge distinguished by rough stone at the bottom and curve inward from there of all but the topmost courses.

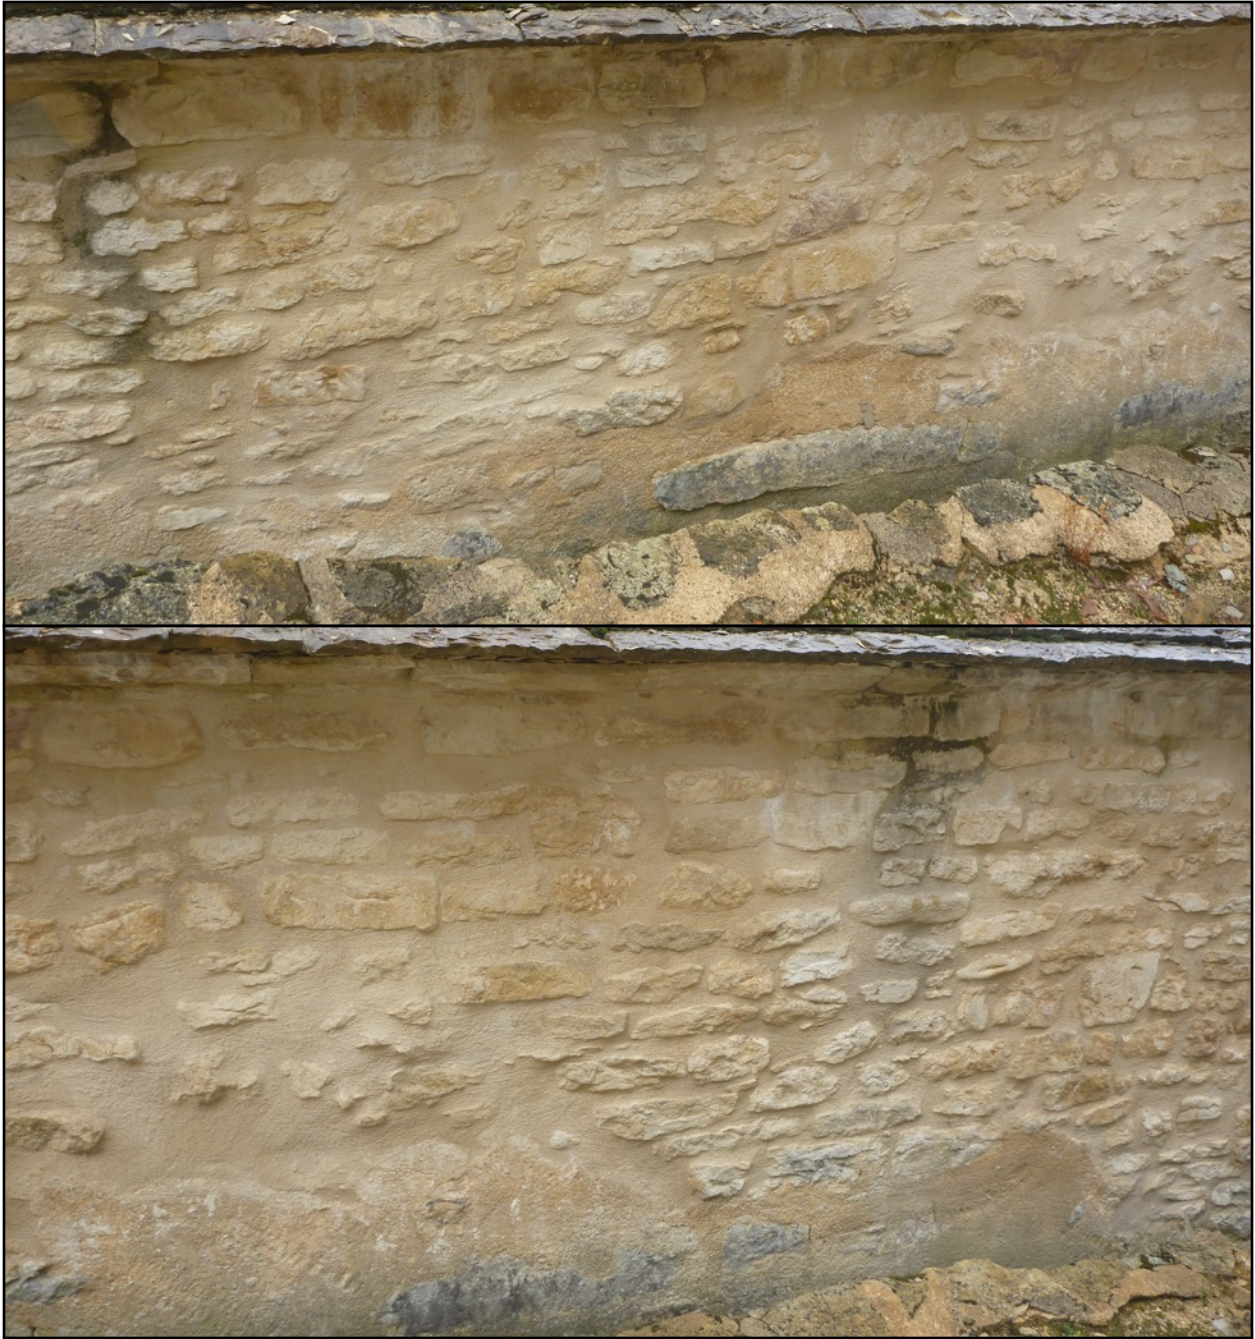
Figure 13: Middle section of south wall stretching from about 3.5 m east of west end to 8 m east. Top is west; bottom is east. Note large grey stones at the bottom.

wall (Figure 13) stretches eastward from the moisture stain until just short of the full 8.0 metres mark as measured from the west. The topmost course is composed of large stones of relatively even size to support the roof. Next down are three or four courses which closely match the stones

of the east end. These courses extend further down on both the east and west ends of this middle section. Small irregular stones heavily covered in mortar are then underpinned by two long, grey stones that are the lowest identifiable stones. The far east end of the south wall is relatively well ordered and corresponds well with the east end of the building. The phasing observed in this wall is essential for the analysis to follow.

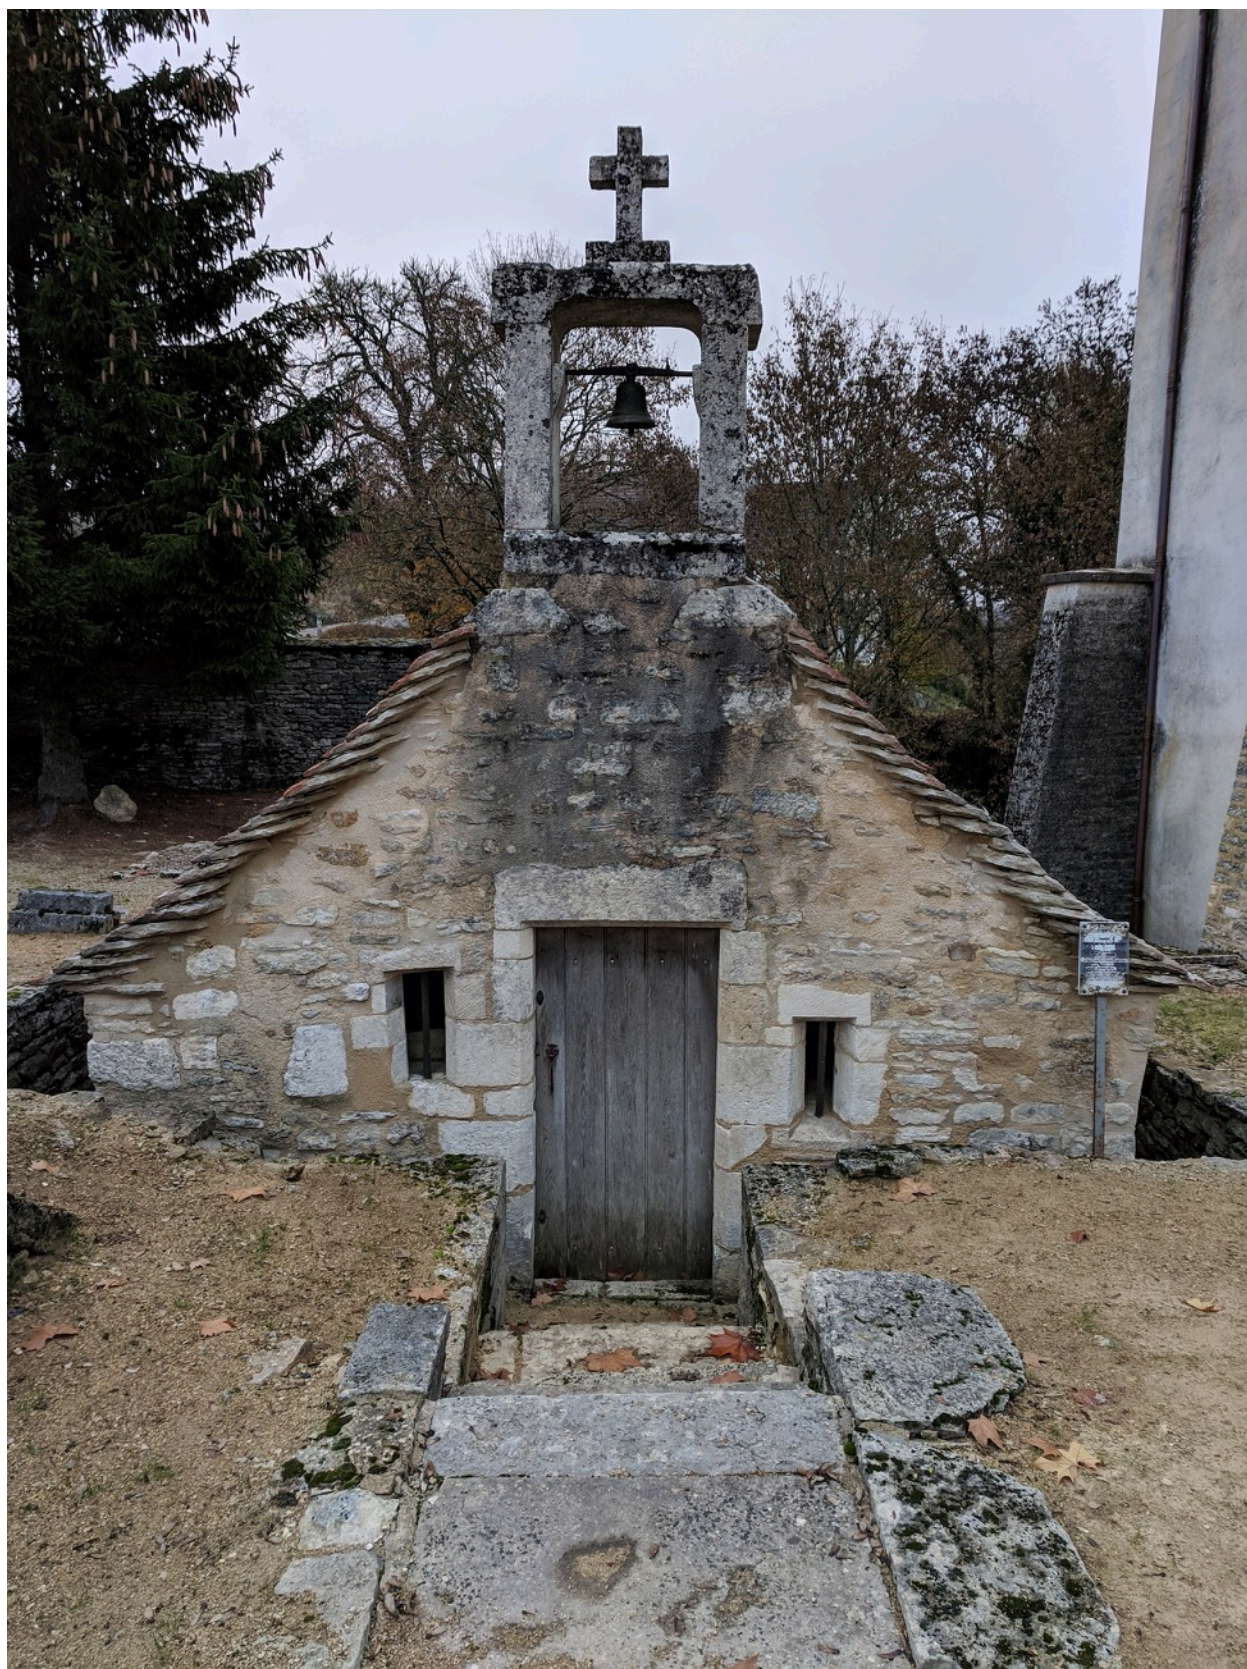
Figure 14: West end of chapel.

The west end of the chapel, with the only entrance still used at the time of this survey, has some well dressed stones used around the door and the two unglazed windows, but is otherwise characterised by irregular stones arranged in loose courses (Figure 14). A belfry composed of at least three large pieces of stone sits well above the door with a slight sag to the south. The base of the belfry was measured to lie 3.36 metres above the ground at the southern edge of the doorway. The staining of the mortar beneath the belfry is quite noticeable even when the weather is dry. Several different types of mortar and/or concrete are visible. This side of the building stretches unevenly from side to side for a measured width of some 4.58 metres at 1.20 metres above ground level at the southern edge of the doorway. The lintel is chamfered as are the stones around the door frame and windows, with only one exception. The bottom stone of the northern window is not chamfered. The windows are not at the same height. Each window contains a substantial, vertical iron bar that is perhaps to strengthen the weight-bearing potential of the windows. The threshold stone is split in an asymmetric manner with respect to the door and belfry. The split rests towards the north side of the building. The front of the building is a confused mixture of stones and styles. It is likely that this reflects numerous alterations and repairs over the years.

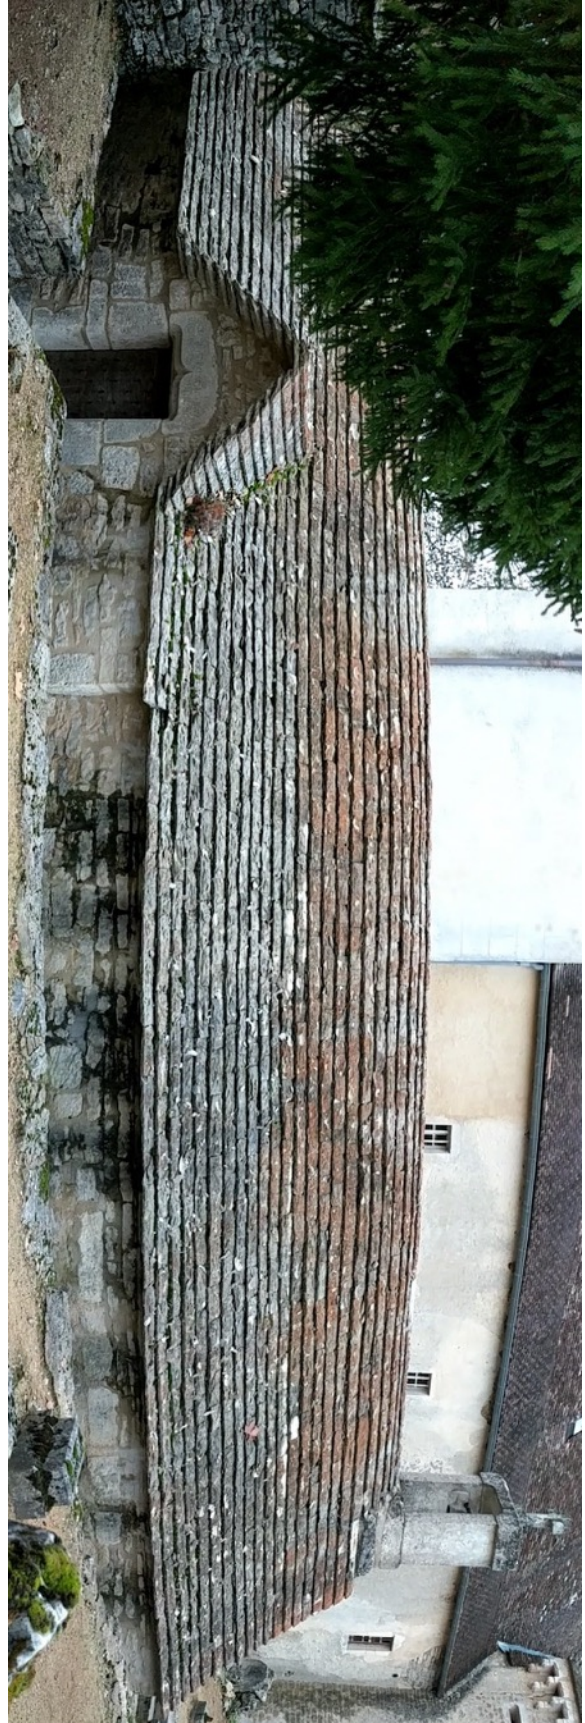
The north wall is heavily obscured by the nearby retaining wall (Figure 15). The visible portion of the wall is 12.15 metres. The section of the north wall at the very east end is blocked by an abutting, perpendicular stone wall with an overlap of some 0.90 metres. At the west end, the height from ground to eaves is 1.20 metres; adjacent to the abutting wall the height is 1.66 metres. A two corner juncture appears 7.13 metres from the west end of the building. The north wall projects out only 0.24 metres as a result of this junction. The associated projection stretches eastward 5.02 metres to the abutting wall. A doorway with gabling above pierces the wall. On the chamfered, ogee arched lintel lies the only external inscription. The chamfering continues down the doorframe. The retaining wall has prevented recent cleaning of the parts of the wall.

Figure 15: North side of building photographed in panoramic style from the northwest. An inscription is found above the door beneath the gable. The retaining wall obscures the lower courses of the building.

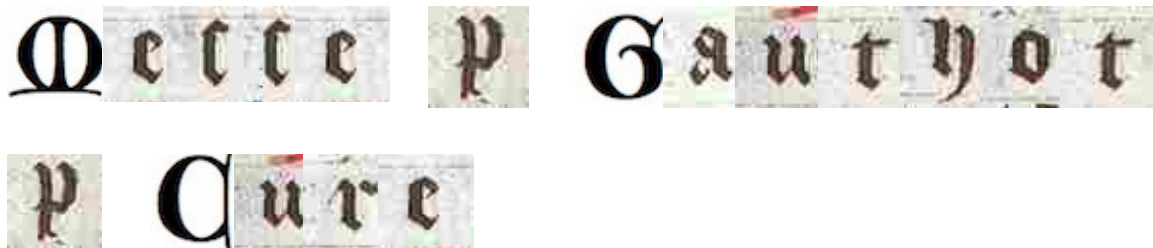
Figure 17: Reconstruction of ‘Messe p Gauthot p Cure’ using the lettering of TILLOTSON (2011) and MARCOS (2017: 57) for comparison to inscription in Figure 16.

The script of this inscription appears to be a variant of the Gothic textura (textualis) that spread from northern France and Belgium as early as the eleventh century with very similar lettering found in later manuscripts (BISCHOFF 1990: 127). A reconstruction (Figure 17) of the reported inscription has been made with the lower-case lettering of TILLOTSON(2011) and the upper-case lettering of MARCOS(2017: 57). The latter is described as a ‘Gothic Textura Prescissa’, but both fonts are based on expensively produced manuscripts of the fourteenth and fifteenth century. In this light, the script used for the inscription might be better described as a ‘Gothic bastarda’ or *lettres bourguignonnes* (BISCHOFF 1990: 143). The presence of apparent colons in the text is part of a trend that started at the end of the thirteenth century to add punctuation to increase readability (DEBIAIS *et al.* 2007: 132). This reconstruction seems to correspond quite well with the first line of the photographed inscription in Figure 16.

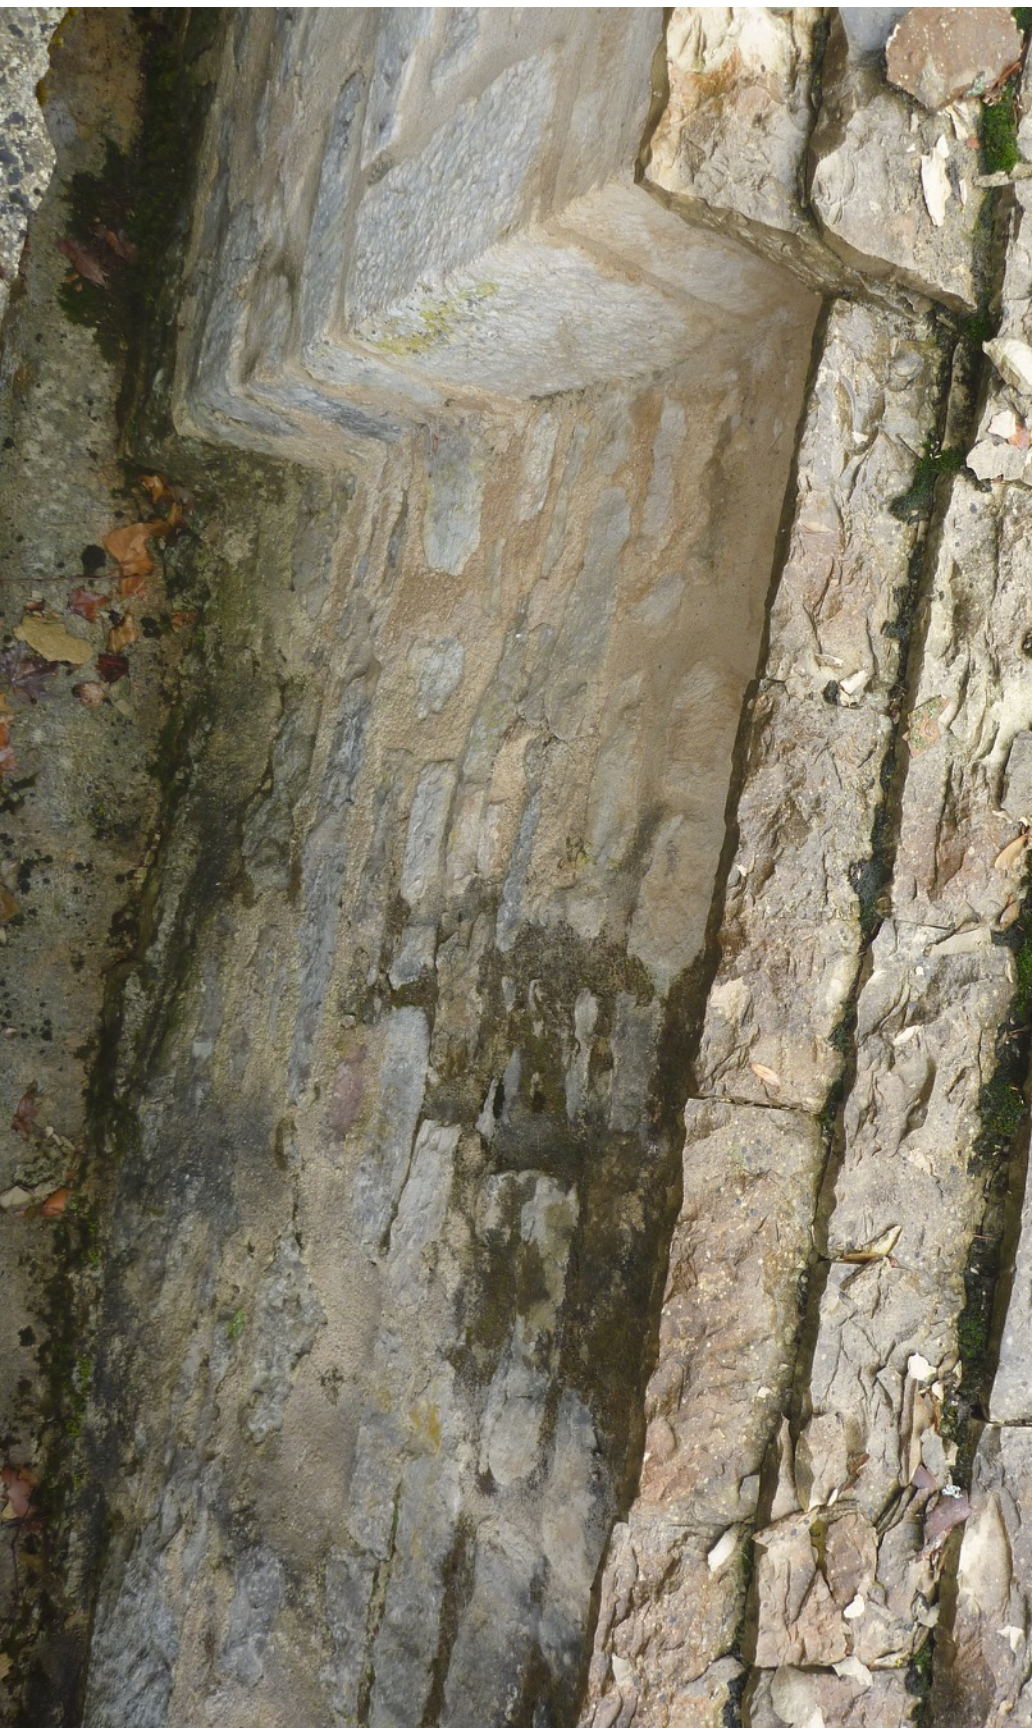
A close examination of the northern wall juncture with its two sharp corners could in principle indicate which section of the building came first (Figure 18). Because of the need for cleaning and the ambiguity caused by a lot of obscuring mortar, no obvious conclusion can be made. Nonetheless, this corner does have important implications for identifying the oldest stonework. The stonework at the top of the exterior corner seems to be part of relatively consistently sized course that appears on both the north and south walls. This course is distinctive for its relative uniformity. This evenness helps to provide a consistent base for the roof. The large quoin in the penultimate, topmost course seems to have a border at the interior corner. Very similar stones are found at the northwest corner, the southeast corner and northeast corner of the building. Beneath this large quoin are what appears to be three, relatively flat stones in a version of face-alternate quoining. The middle one could extend into the interior corner. Below this section, the stonework is much less clear with mortar and moss covering much of the stonework. What is visible is several smaller, heavily mortared stones of apparently the same type as the face-alternating above them. These stones are irregular in shape. These same irregularly sized, rough stones continue both to the east and to the west. At ground level is what appears to be a single, nicely squared flat stone of indeterminate size. Perhaps this stone is a

Figure 18: Detail of north wall juncture at 7.13 metres east of west end of building.

found Roman stone, but it could indicate a different context. Nowhere else is there supporting data for such a different context. The smaller irregular stones appear then to be the oldest stonework, but could be the same as those of the face-alternating quoins. The colour of these stones, but obviously not the size, is consistent with those of the large stones found at the base of the middle section of the south wall (see Figure 13).

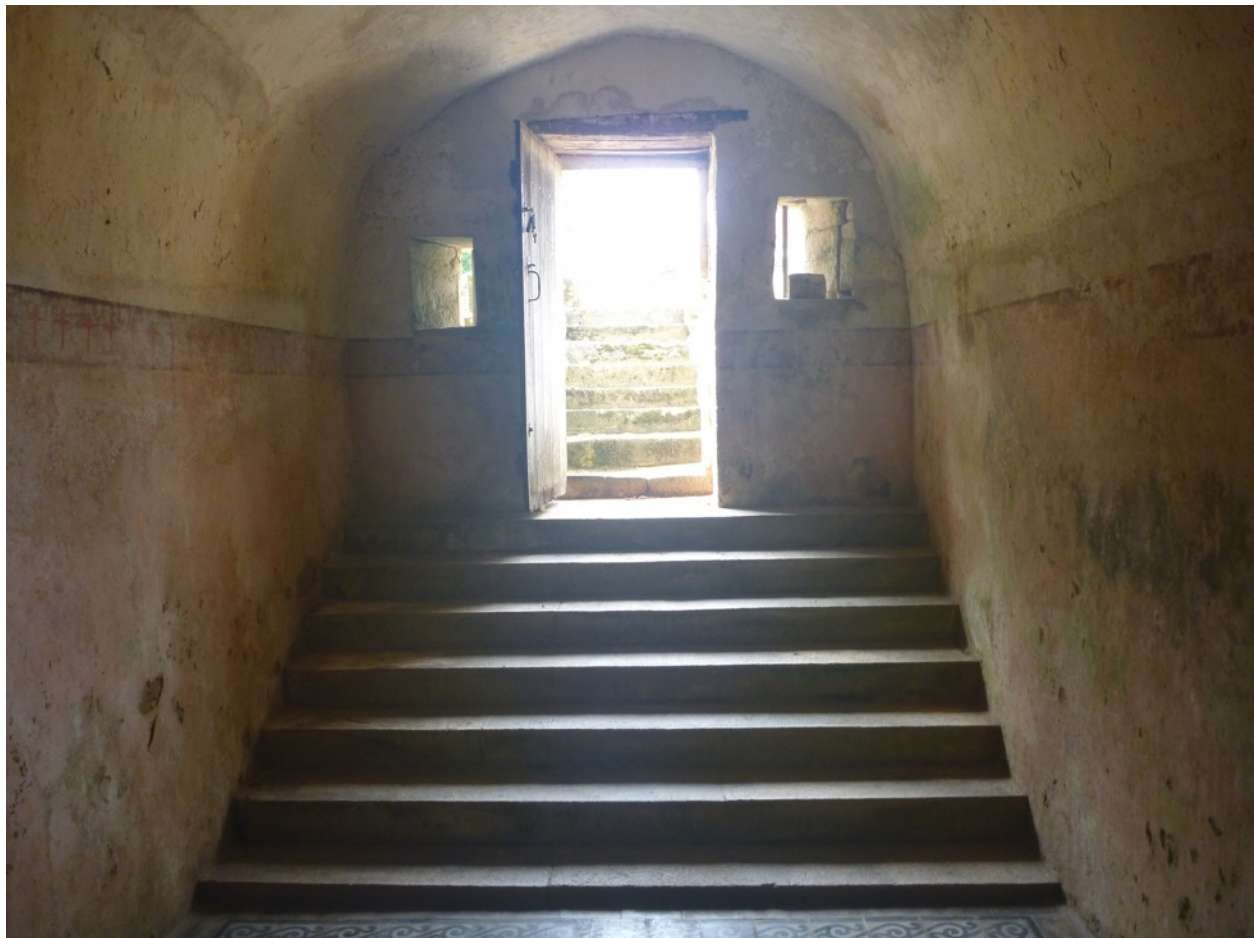
Figure 19: Interior view of western entrance from the base of the stairs.

to a patterned, tiled floor. The last step rises only 0.05 metres above the tiling of the floor and appears to descend below the level of the tiling (Figure 19). The tiling surrounds a sarcophagus on the north side of the nave with the tiles cut to match the edge without disrupting the pattern (Figure 20). The nave is 5.66 metres long. The chancel area is demarcated by a step up of 0.14 metres, a change in tiling and altar rails. A second doorway on the north side of the building enters just after the rails. Towards the east end is a wide platform on which two, clearly movable statues stand. This 1.88-metre wide platform is only approximately centred with respect to the walls but is centrally placed under the window at the east end of the chapel. A 1.5 metre wide altar rises up behind this platform and is also centred with respect to the window but not the
