The Chapel of Saint Frodulphe, Barjon, France

Title of Module: AR7524 The Archaeology of Standing Buildings

The Chapel of St. Frodulphe

Barjon, France

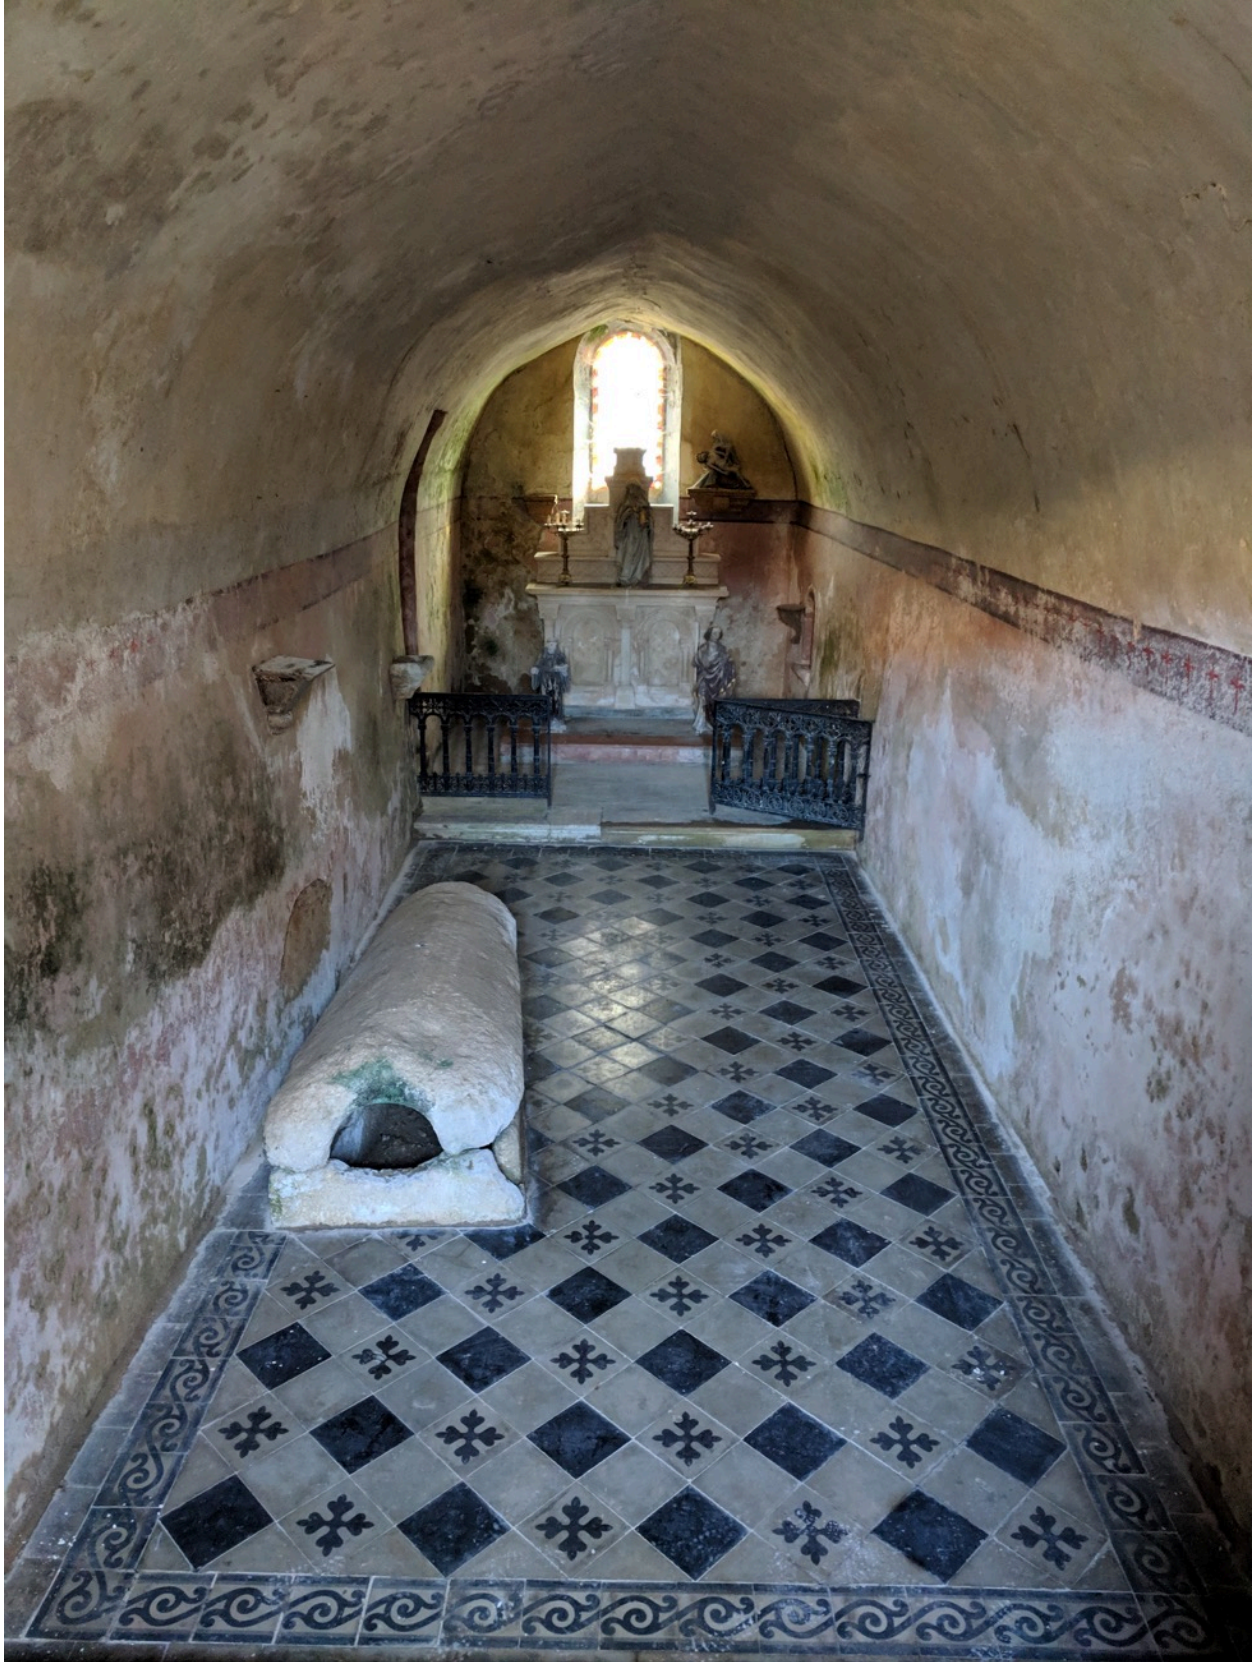
Figure 20: Interior of chapel from top of western stairs.

The chapel of Saint Frodulphe appears as a single-celled building on the inside but as a two-celled building on the outside. In the interior the chancel is differentiated from the nave by altar railings and a small step up (Figure 20). Such an arrangement is found in 'small parish churches, manorial chapels, castle chapels and those attached to colleges and other institutions' (RODWELL 2012: 66). The exterior reflects a two-celled plan as seen in the 0.24 metre projection on the north side of the building toward the east end (Figure 15). For a medieval parish church, the maintenance of a church's two parts, the chancel and the nave, fell to different groups respectively: the rector and the people (RODWELL 2012: 67). The interpretation of the inscription over the north door ascribes a curate as being responsible for construction in 1486 (Figure 16). If this construction was for a manorial or castle chapel, the entire extent of the 1486 building may have been restricted to the chancel area. The double corner juncture, however, appears to have similar stonework going both to the east and to the west away from the juncture in the lowest stone courses (Figure 18). These courses likely represent the original stonework for this date and suggest that the chancel and nave were constructed at the same time.

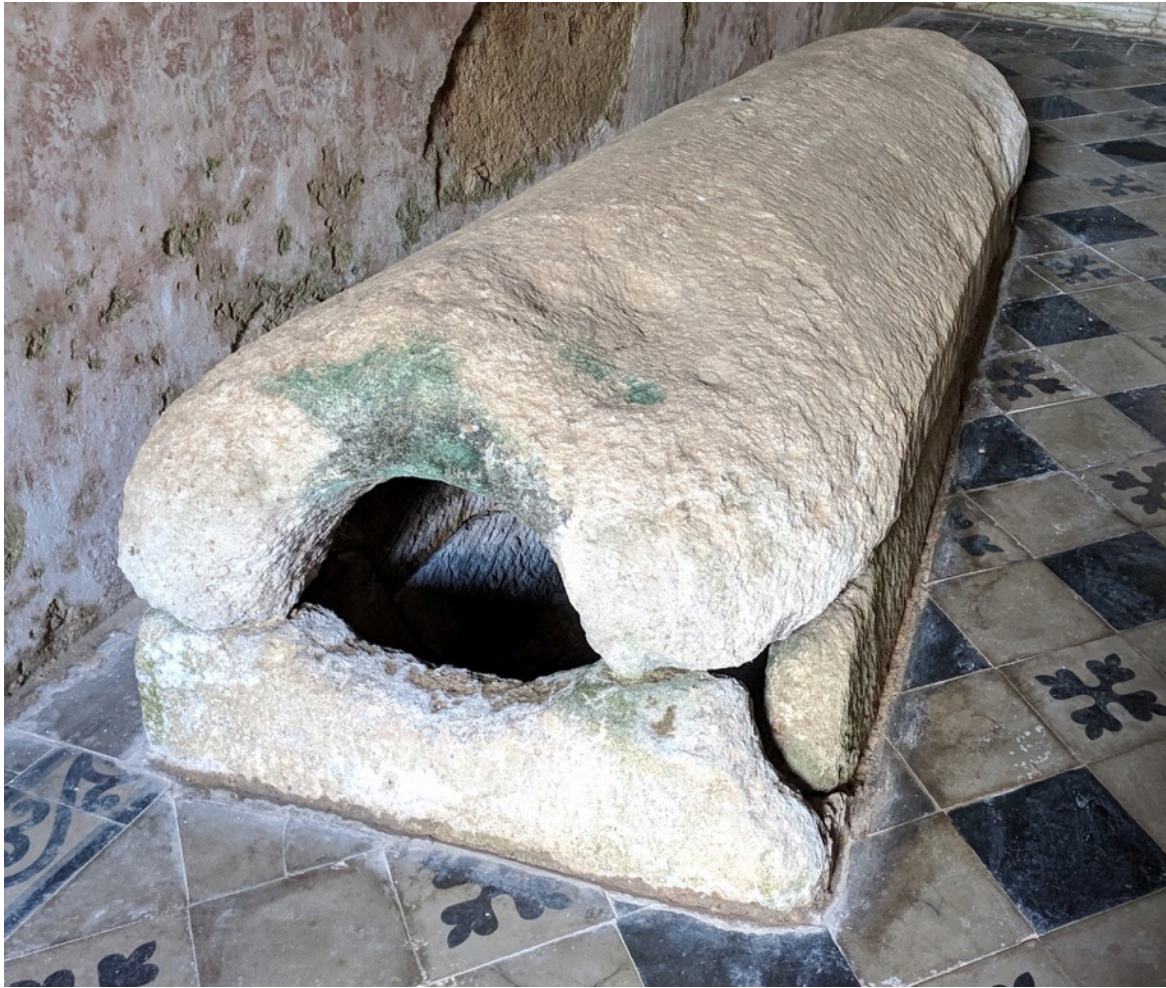
Figure 23: Sarcophagus inside chapel of St. Frodulphe. Drawing from COROT (1917) and photograph.

COROT (1917) presented the first known depiction of the sarcophagus in a publication (Figure 23). COROT mentions the circular opening at the end, sometimes referred to as a fenestella, and the tradition of placing one's head inside the opening to cure migraines. Such openings generally permit the viewing of relics. Noting the pattern of lines represented in COROT's depiction, modern reference is made to bands of light relief (RATEL and RATEL 2009: 44). Such an impression is hard to confirm with modern photography, but the reported shape of the stone is. Much more noticeable is the presence of an inscription (Figure 24). A plausible transcription of the part still legible is (DEGOIX 2018):

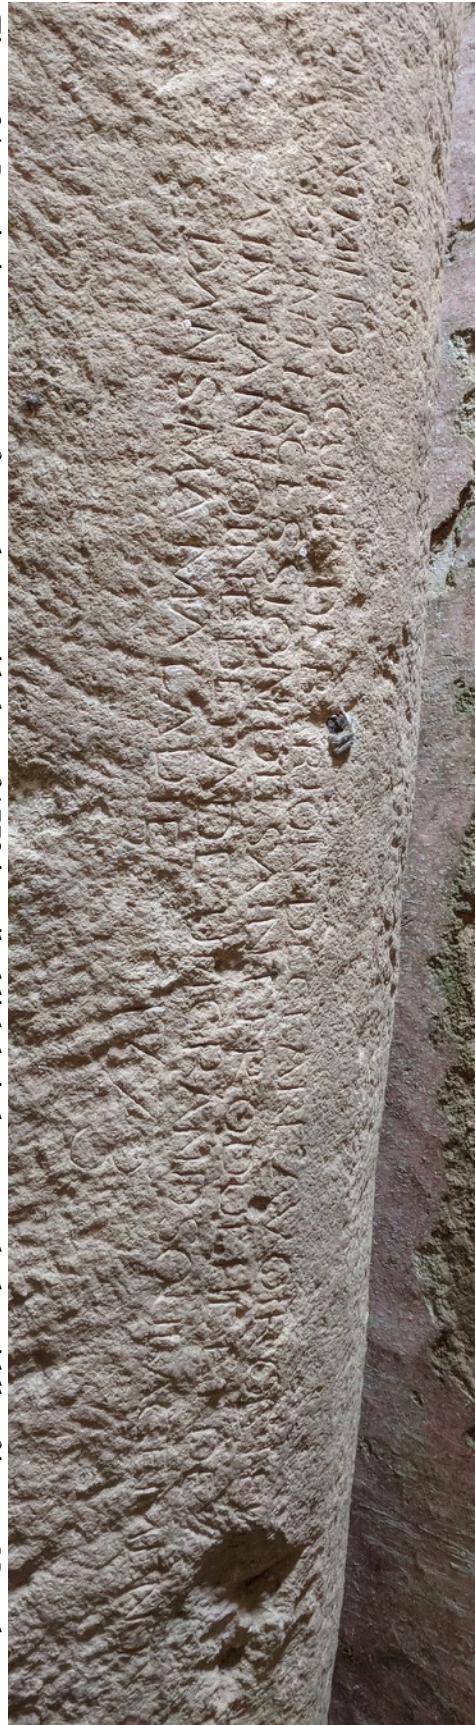
A large indentation at the end of the first and second lines as well as numerous smaller dints in the inscription suggest significant damage occurred after 1773, perhaps during the French revolution. If destruction were the aim, the vandals gave up. That the building may have

Figure 24: Inscription on cover of sarcophagus with date of 1773 inscribed lightly in last towards the middle of image. Note the damage done to the right hand side of the inscription.

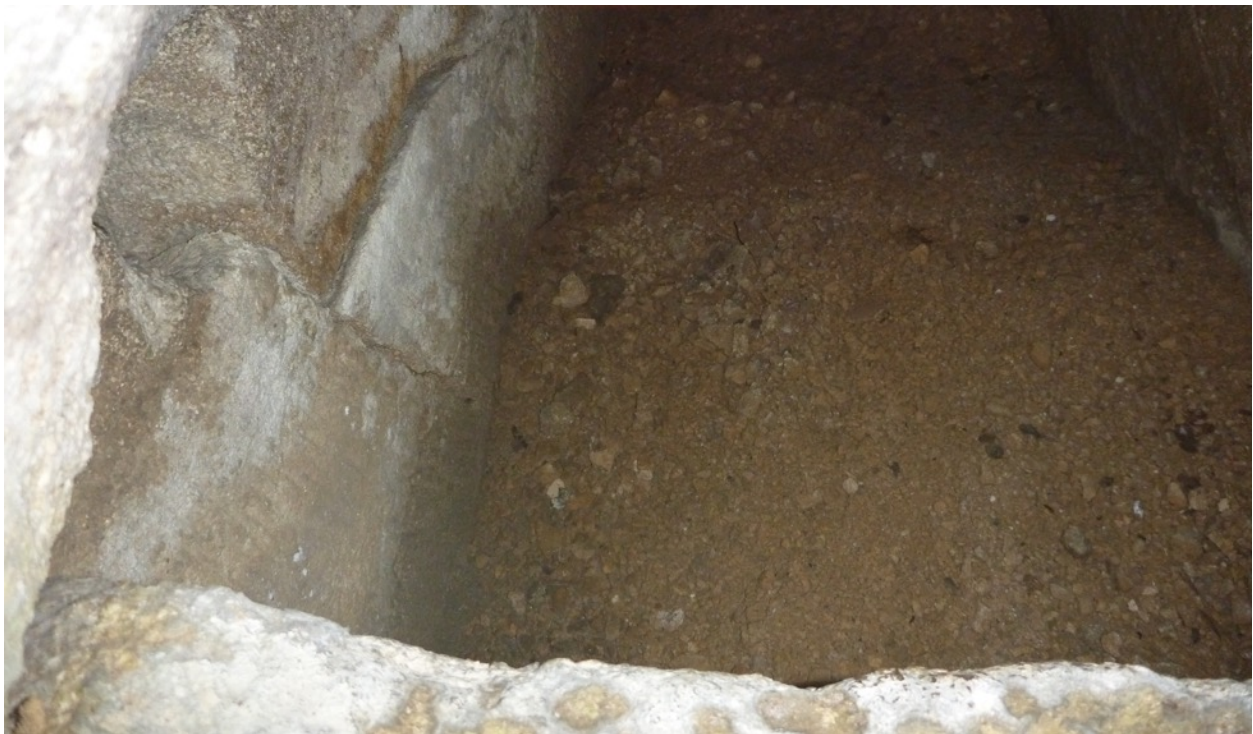
suffered similar treatment is certainly plausible. The damage to the sarcophagus could have resulted from a collapse of the building. At any point the sarcophagus could have been moved but only if the motivation and resources were there. The formidable bulk of the cover suggests a lot of weight. The possible immobility of the sarcophagus is also suggested by the view of the interior of the sarcophagus (Figure 25). The observable cracks in the side could be the result of the force used to create the fenestella or from stress from water or weight while the sarcophagus was, presumably, buried. More interesting is the lack of a visible bottom to the sarcophagus. The rocky soil beneath the sarcophagus' cover could represent the ground on which the body was

Figure 25: Photograph through the fenestella of the sarcophagus. Numerous fractures in the side and a bottom of rocky soil are apparent.

lain, the floor of the original building or the later floor if the sarcophagus had been moved. If the sarcophagus was buried, water flow may have led to the accumulation of soil and rock on top of

a now invisible bottom. Although far from irrefutable, overall, the evidence lends itself most easily to the idea that the sarcophagus was not moved.

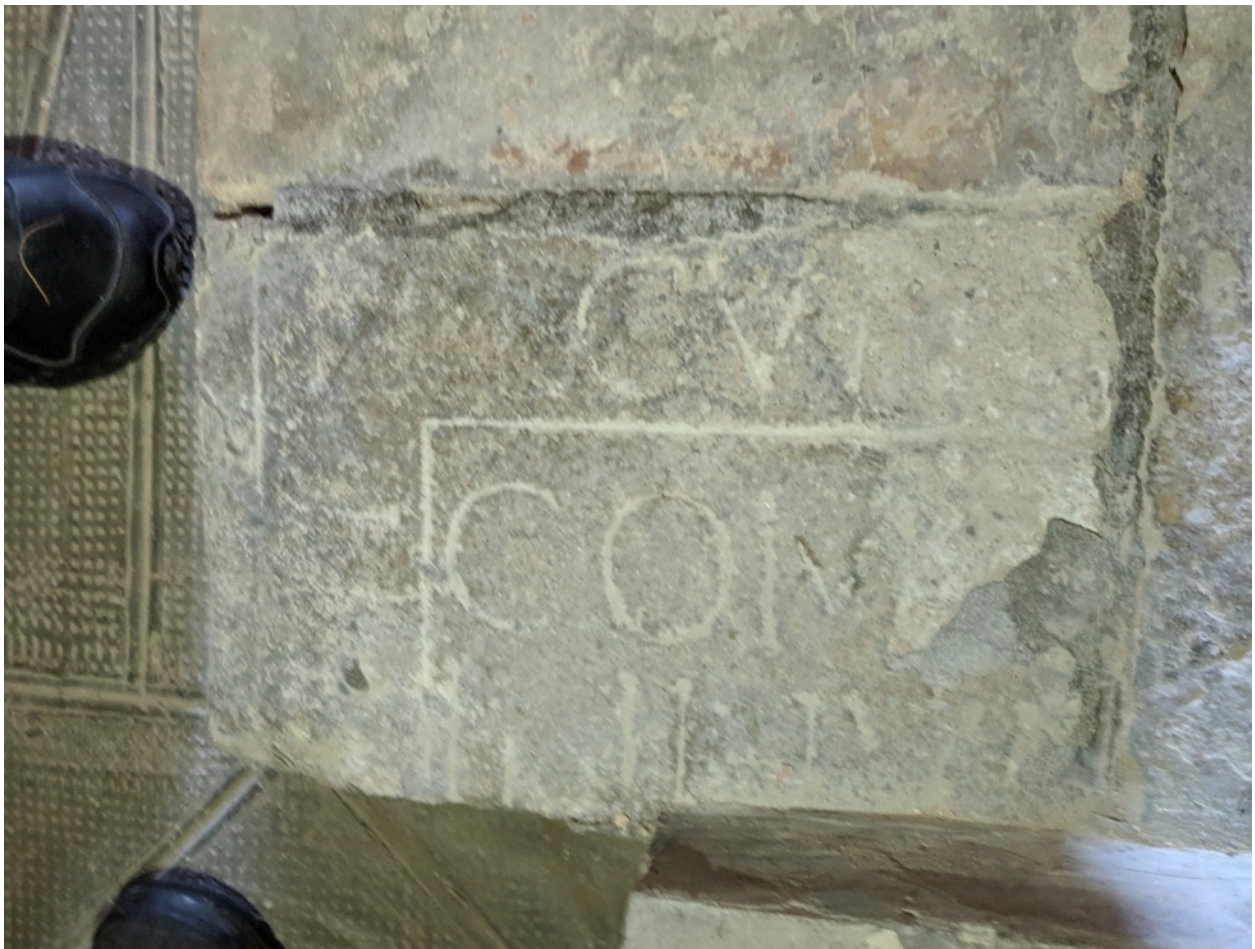
A part of an inscription, previously covered entirely with plaster, is now visible on the southeast corner of the platform or step immediately in front of the altar (Figure 26). The

Figure 26: Partial inscription on southeast corner of platform in front of altar, the edge of which is a the bottom right of the photo.

inscription appears to be the upper left hand of a larger inscription. The lettering appears to be in three lines, but the presence of a border may indicate that the top line is part of a border

inscription around a central text. Notably, the inscription does not appear to be in an original position. It was apparently reused.

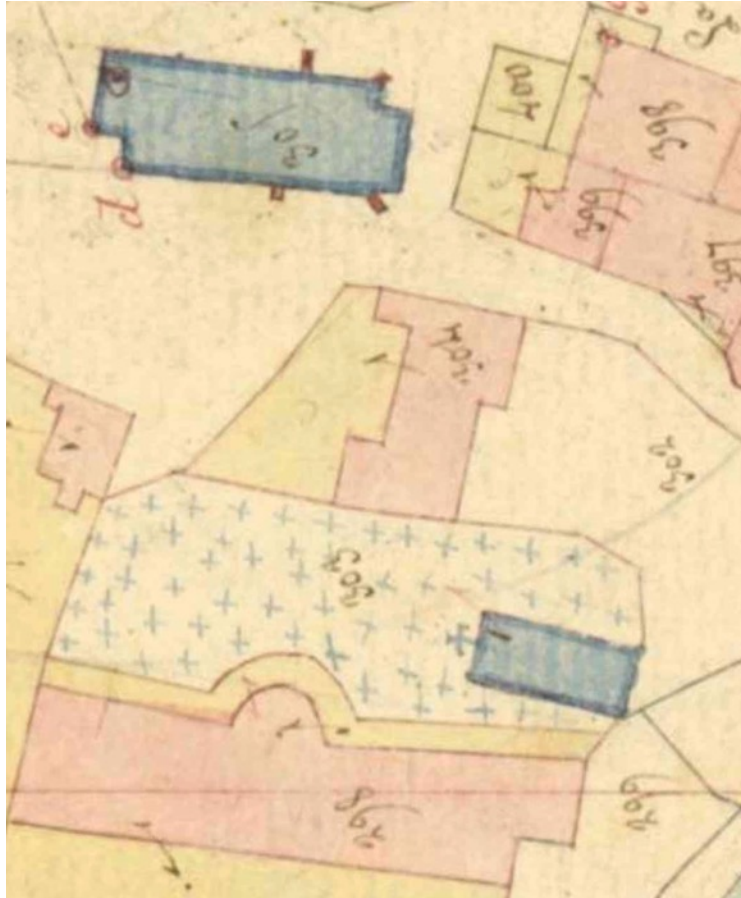
Figure 27: Early nineteenth century map to compare to modern aerial view of Figure 2 (Cadastre Napoléonien 1836).

perspective on several different aspects of the building and its history. Figure 27 shows that the basic arrangement and form of the chateau, chapel and church have not changed substantially since the early part of the nineteenth century. The map was rotated to allow an easier comparison.
